# **INDOOR AIR QUALITY ASSESSMENT**

**Berkley Community School  
59 South Main Street  
Berkley, Massachusetts**

Prepared by:  
Massachusetts Department of Public Health  
Bureau of Environmental Health Assessment  
March, 2002

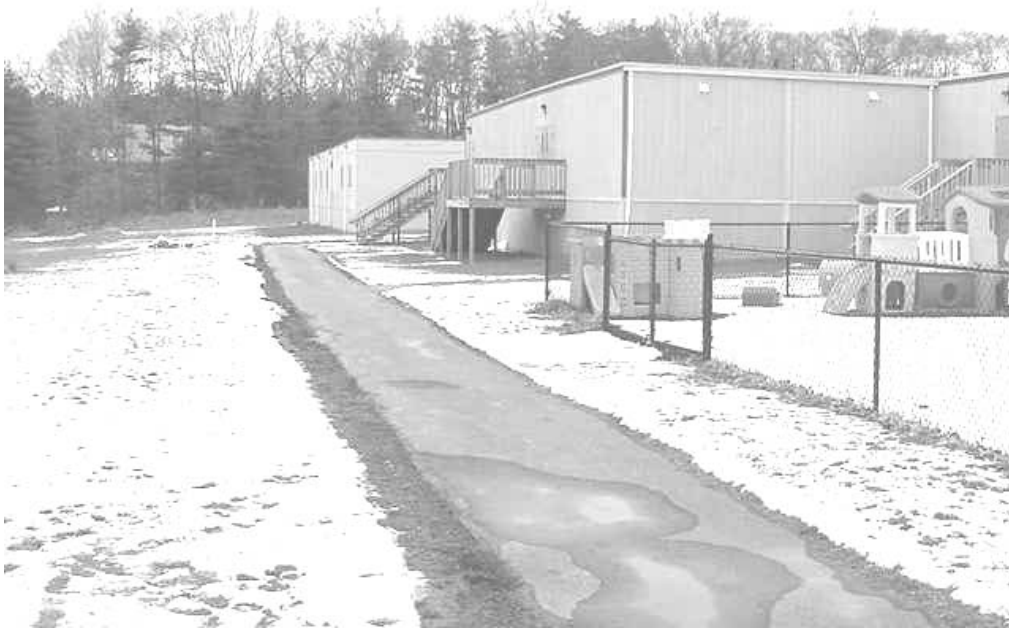
**Picture 1**

The BCS is a two-story brick building originally built in 1962. The existing building was completely renovated and an addition was built in 1989 (see Cover Photo). Two modular classroom wings were added in 1996 and 1998 (see Picture 1). The 1996 modular classroom wing is freestanding. The 1998 modular classrooms are connected to the northeast side of the building via a corridor and are reportedly scheduled to be removed over the next six months. Use of the 1996 modular classroom wing by students will be discontinued at the start of the next academic school year. These modulares will reportedly be rented by senior citizen programs and town offices. In addition, the Berkley School Department (BSD) has reportedly been allotted two-million dollars to conduct renovations, which will include roof work and interior renovation of six rooms of the 1962 wing.

**1996 & 1998 Modular Classroom Wings**

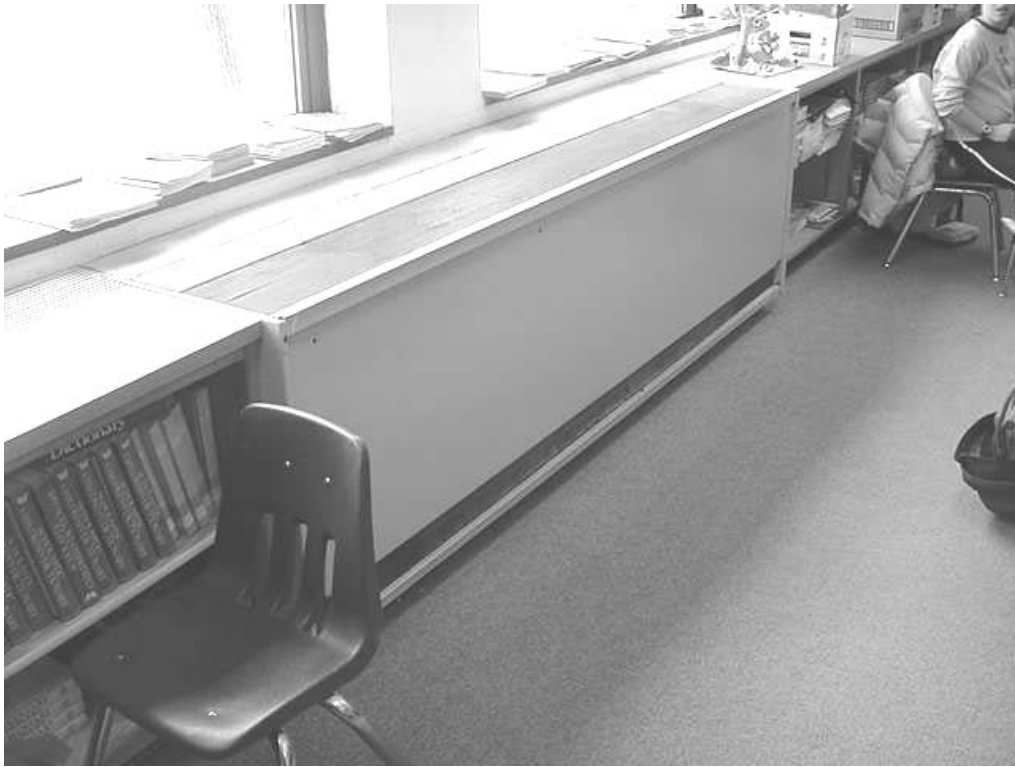
**Picture 2**

Fresh air in classrooms is supplied by a unit ventilator (univent) system (see Picture 2). Univents draw air from outdoors through a fresh air intake located on the exterior walls of the building (see Picture 3) and return air through an air intake located at the base of each unit ([see Figure 1](#)). Fresh and return air are mixed, filtered, heated and provided to classrooms through a fresh air diffuser located in the top of the unit. All univents were operable and appeared to be well maintained. Obstructions to airflow, such as items placed in front of univent returns, were seen in a few classrooms (see Picture 4). To function as designed, univents and univent returns must remain free of obstructions.

**Classroom Univent**

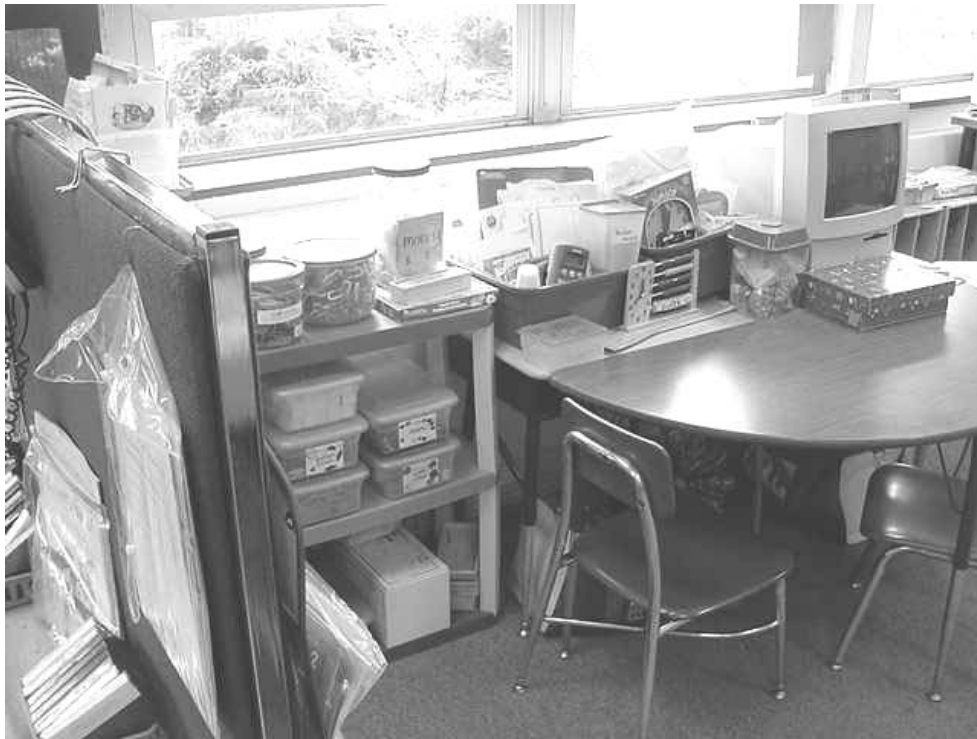
**Picture 4**

**Univent Airflow Obstructed by Various Items**

4. Remove all obstructions from univents and mechanical exhaust vents to facilitate airflow.
5. For buildings in New England, periods of low relative humidity during the winter are often unavoidable. Therefore, scrupulous cleaning practices should be adopted to minimize common indoor air contaminants whose irritant effects can be enhanced when the relative humidity is low. To control for dusts, a HEPA filter equipped vacuum cleaner in conjunction with wet wiping of all surfaces is recommended. Drinking water during the day can help ease some symptoms associated with a dry environment (throat and sinus irritations).

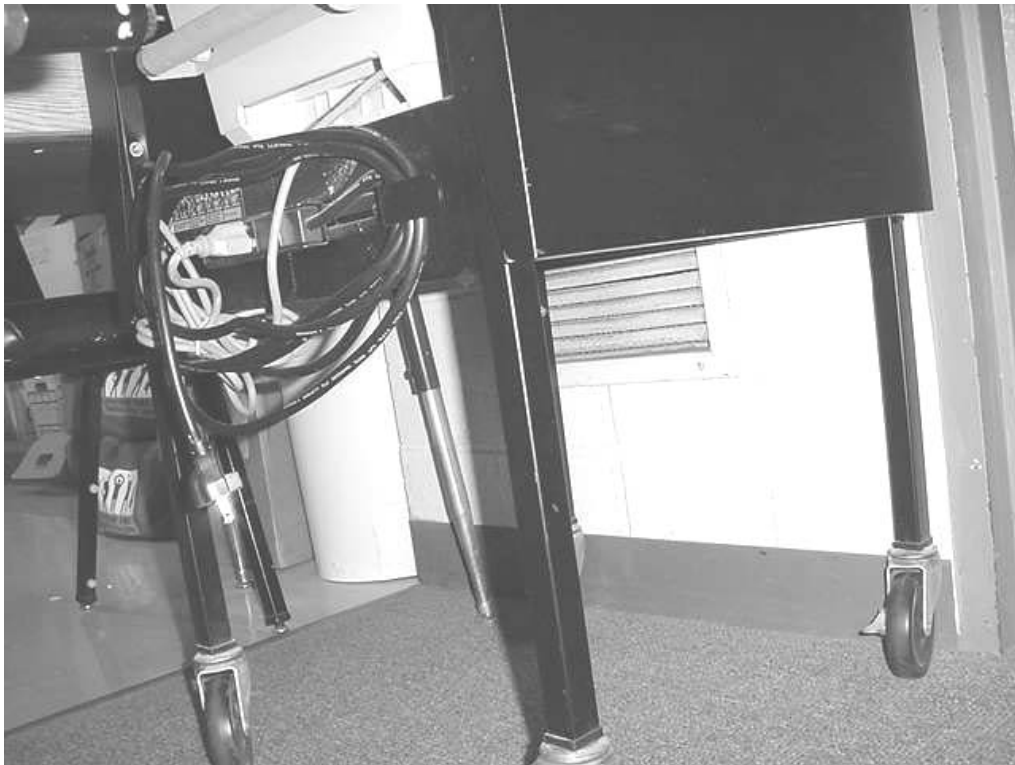
**Picture 5**

Mechanical exhaust ventilation is provided by wall-mounted intake grilles connected to ductwork. As with the univents, a number of exhaust vents were obstructed by computer carts and other items (see Picture 5). The location of some exhaust vents can also limit exhaust efficiency when the classroom hallway door is open (see Picture 6). When a classroom door is open, exhaust vents will tend to draw air from both the hallway and the classroom. The open hallway door reduces the effectiveness of an operating exhaust vent to remove common environmental pollutants from classrooms.

**Wall-Mounted Exhaust Vent Partially Obstructed by Computer Cart**

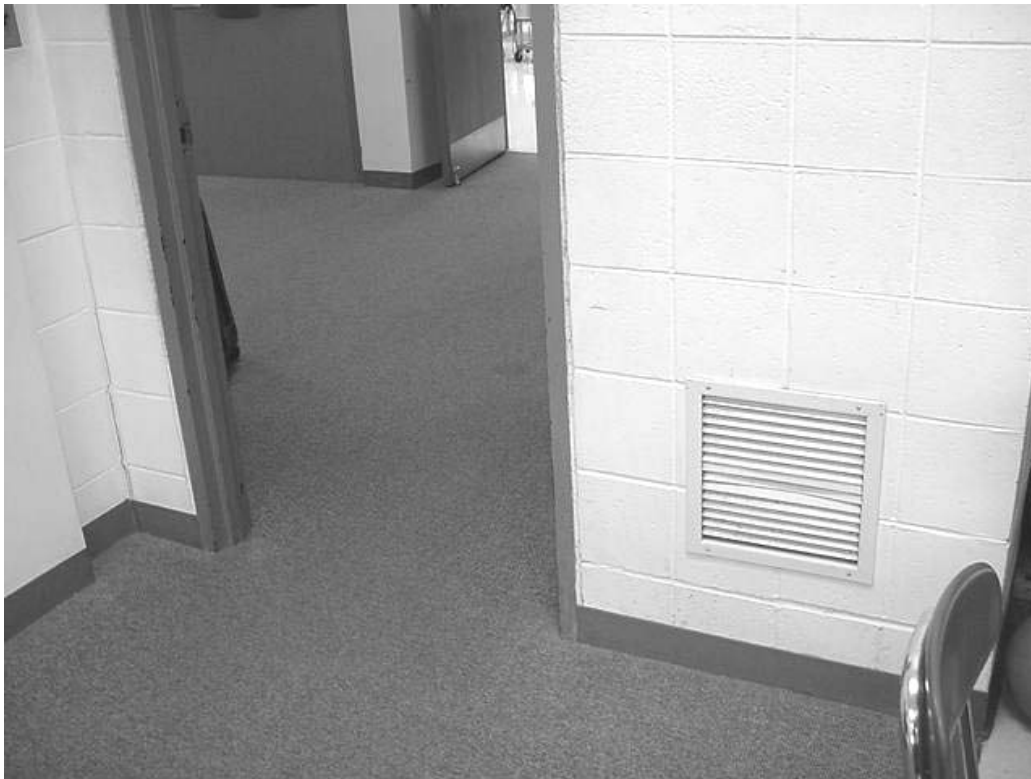
**Picture 6**

**Classroom Exhaust Vent, Note open Hallway Door**

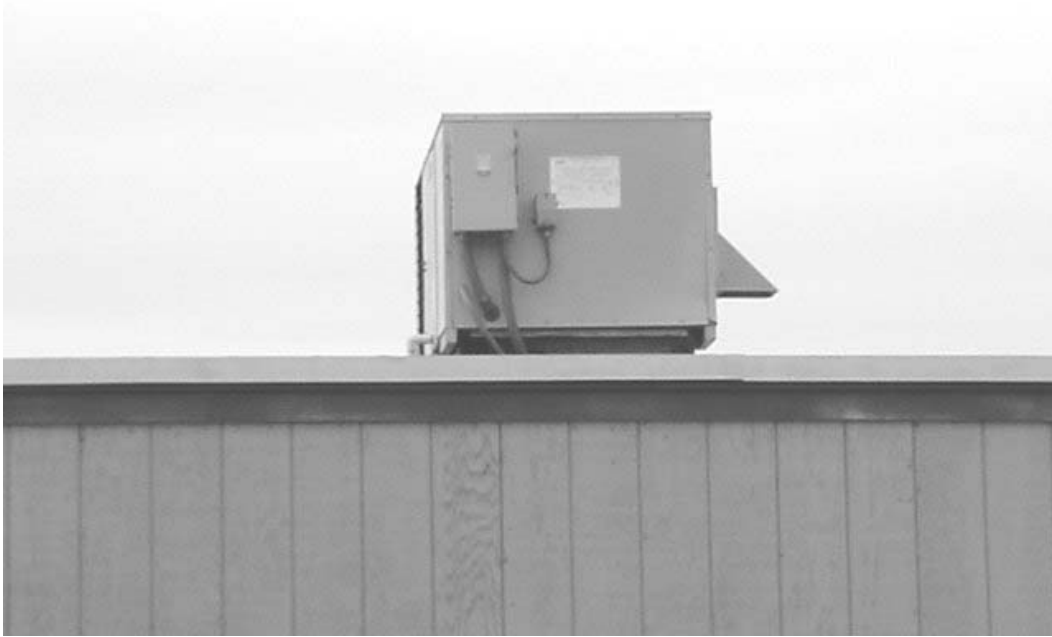
**Picture 7**

Ventilation in the modular classroom wings is provided by rooftop air handling units (AHUs) (see Picture 7). Fresh air is distributed to classrooms via ductwork connected to ceiling-mounted air diffusers. The amount of fresh air drawn into the units is controlled by moveable louvers connected to an activator motor that adjusts to alter fresh air intake to maintain temperature. Return vents draw air back to the units through wall or ceiling-mounted grilles. Thermostats control each heating, ventilating and air conditioning (HVAC) system (see Pictures 8 & 9). In modular classrooms, thermostats have settings of “on” and “automatic”. Thermostats were set to the “automatic” setting in most of the modular rooms surveyed during the assessment. The automatic setting on the thermostat activates the HVAC system at a preset temperature. Once a preset temperature is measured

**Rooftop-Mounted AHU for Modular Classroom**

1. Continue to operate supply and exhaust ventilation continuously during periods of school occupancy to maximize air exchange. Operate AHUs for modular classrooms with thermostats in the fan “on” position to provide constant airflow. Contact an HVAC engineering firm to increase the percentage of fresh air intake if necessary.

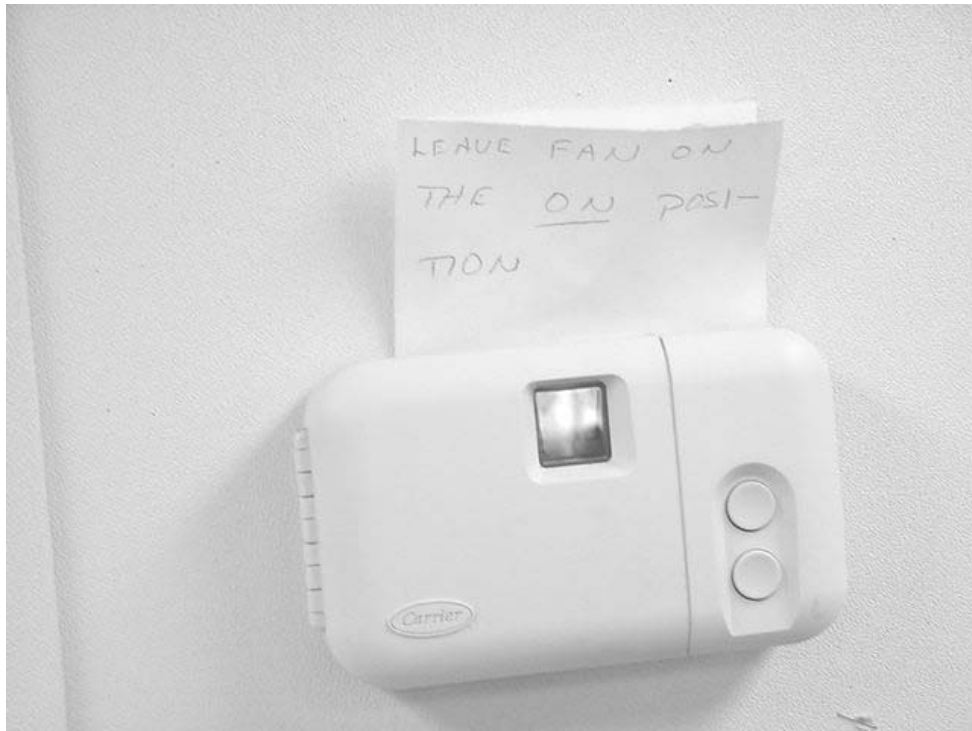
**Picture 8**

**Modular Classroom Thermostat**

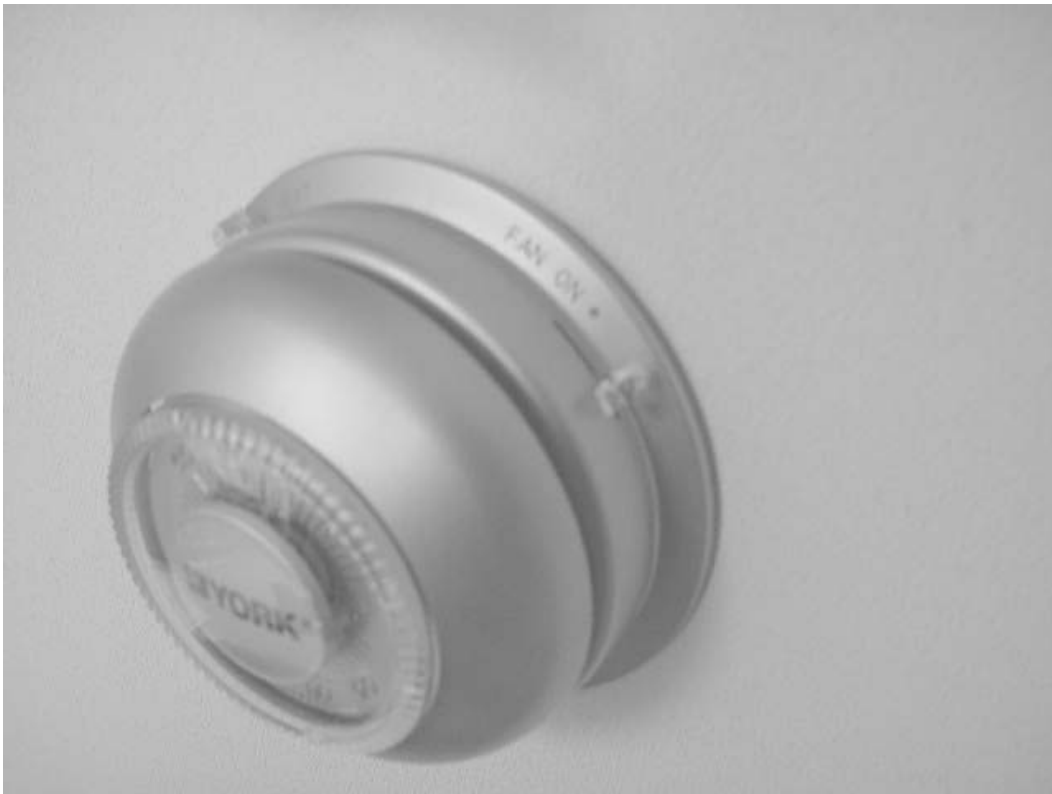
**Picture 9**

by the thermostat, the HVAC system is deactivated. Therefore, no mechanical ventilation is provided until the thermostat re-activates the system. Without dilution and removal by the mechanical ventilation system, normally occurring environmental pollutants can build up and lead to indoor air quality and comfort complaints.

**Modular Classroom Thermostat Note Fan Switch to Auto Position**

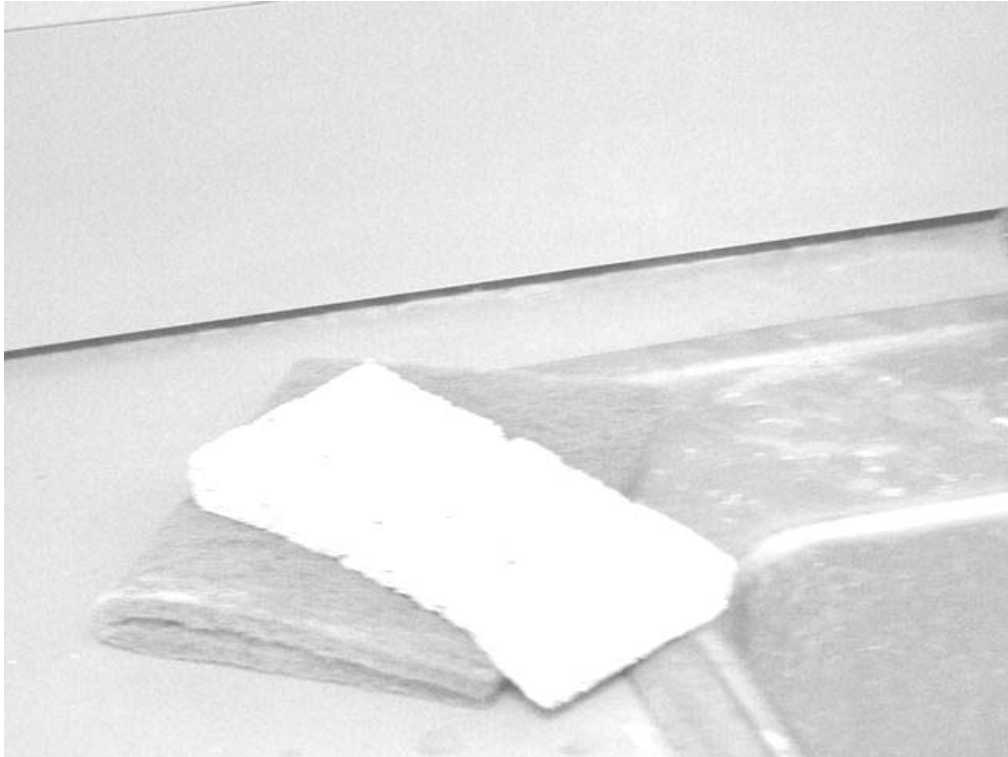
**Picture 10**

In classroom 20, spaces between the sink countertop and backsplash were noted (see Picture 10). Improper drainage/overflow can lead to water penetration of countertop wood, the cabinet interior and behind cabinets. Like other porous materials, if these materials become wet repeatedly it can provide a medium for microbial growth. In a number of classrooms, paper products, board games and other porous items were found stored underneath sinks. If these items become wet repeatedly they can also provide a medium for mold growth. These items should be relocated to a warm, dry environment.

**Space between Sink Countertop and Backsplash**

7. Seal areas around sink in classroom 20 to prevent water-damage to interior of cabinets and adjacent wallboard.
8. Do not store paper products or other cellulose-containing materials beneath sinks.  
To prevent water damage to these materials, remove them from beneath sink and store in a dry area.
